Manhole Inspection Summary

Manhole # **S31C__046MH**

Insp Date: **5/26/09 3:43 PM**

Location Address: **430 PACA ST**

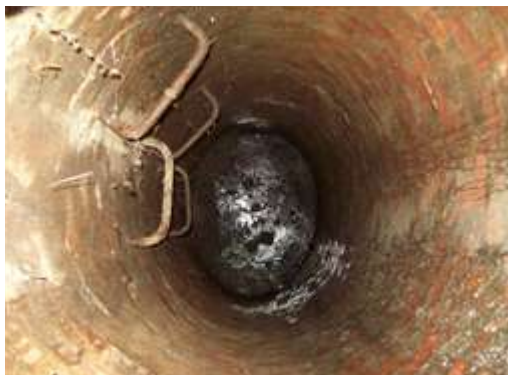
ACTIVE SURCHARGE

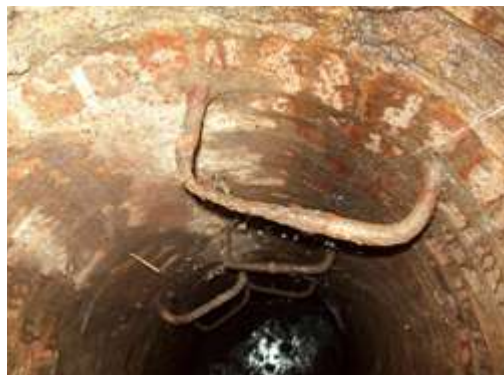
Defect 4

Count: **9** Missing: **1** ☒ **Corroded**

CORODED STEPS

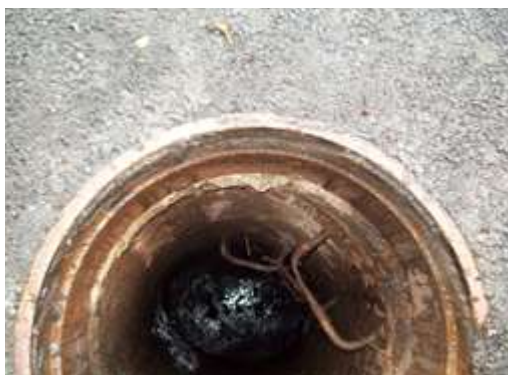
Defect 3

Offset: **1** (in.)

FRAME OFFSET

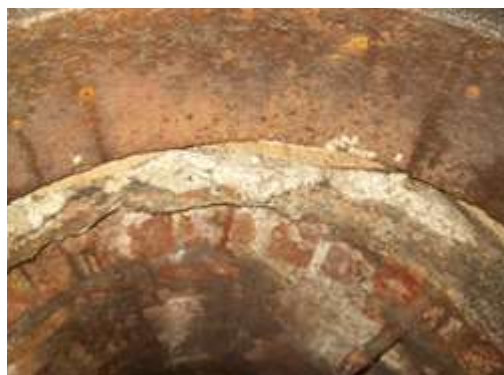
Defect 2

Condition: ☐ Sound ☒ **Cracked** ☐ Root Intrusion ☐ Loose Brick ☐ Deteriorated

Cracked chimney

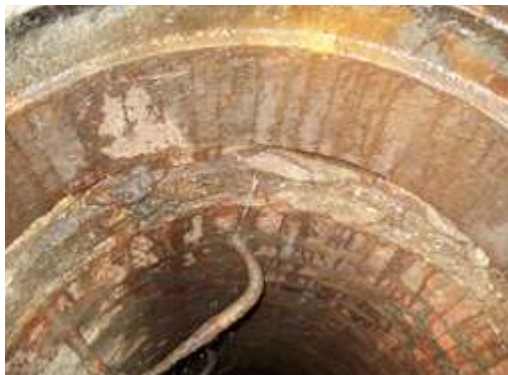
Defect 1

DETERIORATED CHIMNEY

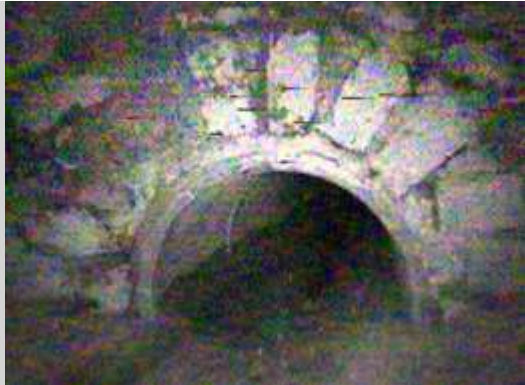
12 O'Clock Outflow

8 in. Circular Gravity Sewer
Pipe Out @ 12 O'Clock

Deposits: ☐ None ☐ Mud ☐ Sludge ☒ **Debris** ☐ Grease

Silt Depth: **2.5** (in.) Deposits Extent: **Light**
